**SOUTHWESTERN COASTAL BASIN  
GREENWICH, CONNECTICUT**

**MIANUS FILTER PLANT DAM  
CT 00040**

**PHASE 1 INSPECTION REPORT  
NATIONAL DAM INSPECTION PROGRAM**

**FEBRUARY, 1980**

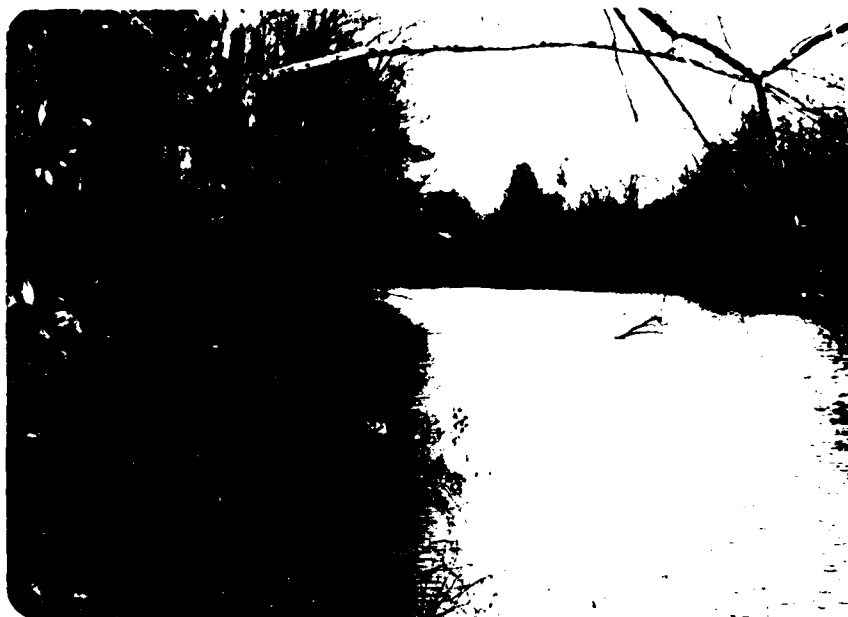
with no visible signs of erosion or sloughing. There were two trees in the riverbed that the maintenance personnel are trying to have removed, but some difficulty was noted (Photo C-1). Concern was expressed that during a heavy storm these trees could be a problem.

C-1 UPSTREAM IMPOUNDMENT - LOOKING FROM WEST BANK

- a. **Operation and Maintenance Procedures:**
  - 1. Trees from the floor of the upstream riverbed should be removed as soon as possible.
  - 2. The seepage on the downstream face should be monitored to note any change from the existing conditions.

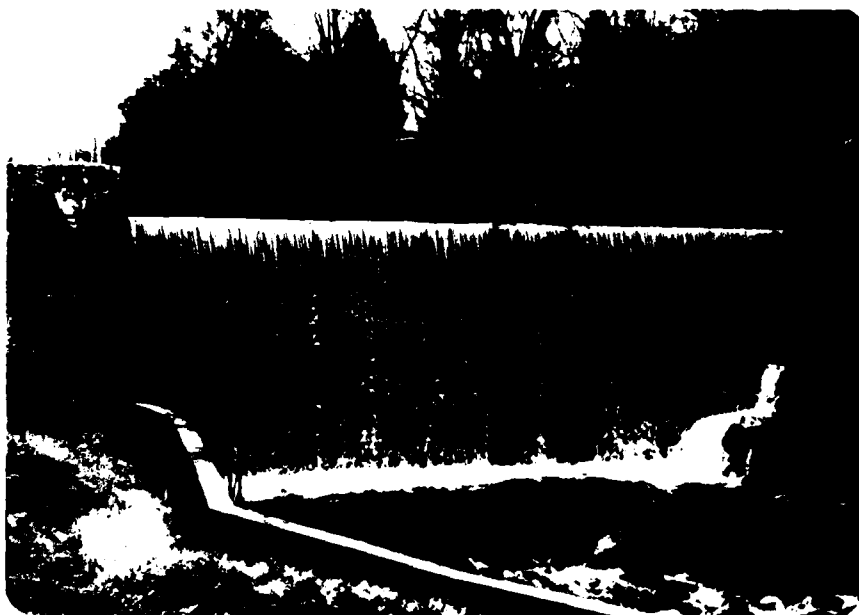
1. **Spillway:** The spillway for the dam is a 65 foot long stone capped weir with a free drop of approximately 28 feet to the tailwater (Photos C-2, 4). The water level on the day of inspection was 30 inches below the east top of the dam and water was flowing over the spillway. The spillway appears to be in generally good condition.

C-2 DOWNSTREAM FACE OF DAM AND SPILLWAY

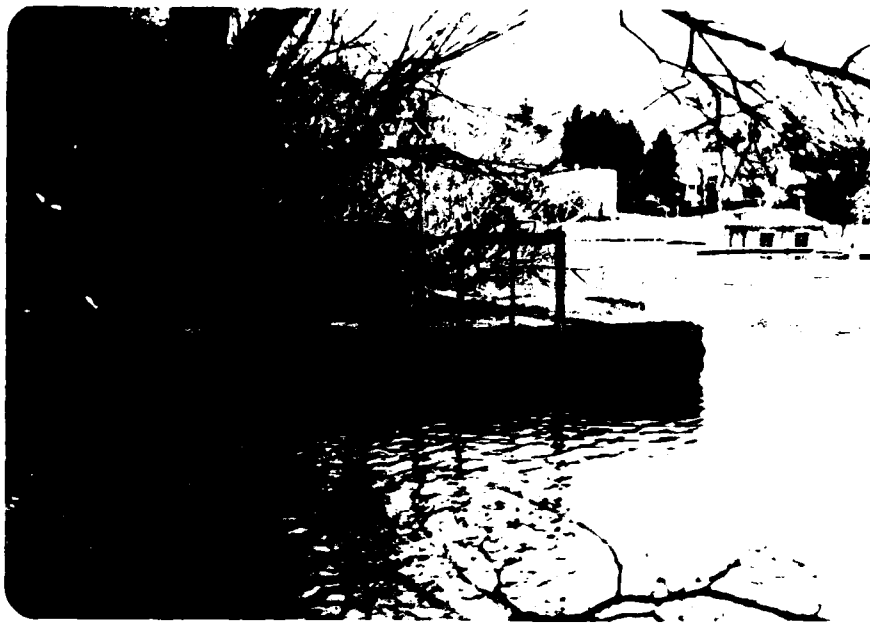
4. **Twin Flood Gates:** Two flood gates are located below the dam's east crest at a shallow level (Photos C-5, 6). They are controlled by lift mechanisms on the top of the dam and appear in good condition. A 4 inch gate valve at the base of the flood gates is maintained in an open condition as per an agreement with adjacent homeowners. A natural, rock discharge channel rejoins the Mianus River just downstream of the dam.

C-5 FLOODGATES ON EAST CREST
